## **“Building Envelope Energy Efficiency Analysis”**

**Doe Residence**  
123 Energy Efficient Lane  
Severna Park, MD 21146

February 17, 2011  
Survey #: Z-1108-Doe

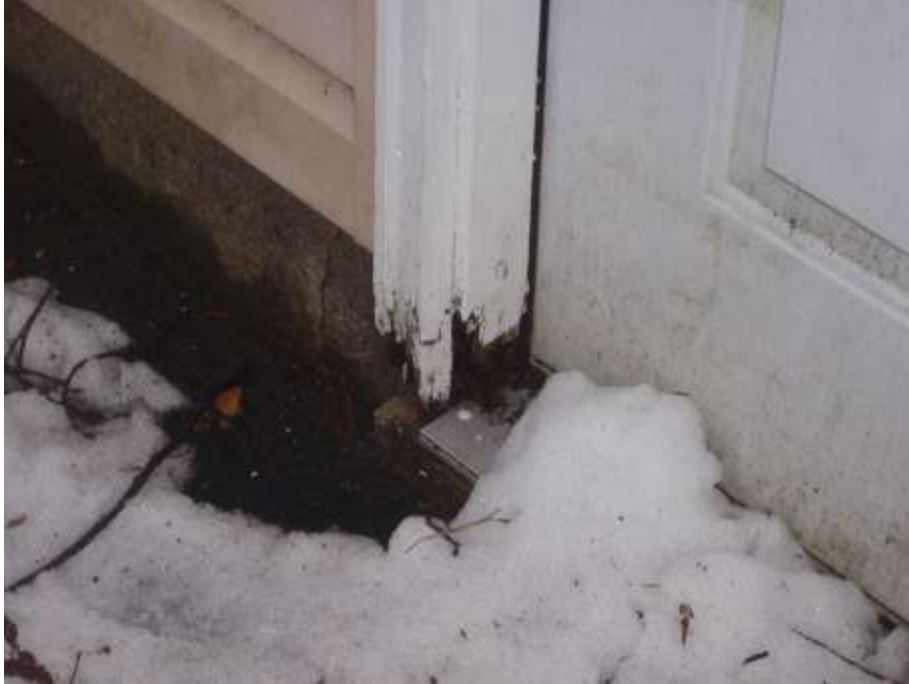
#1 – wood trim around studio door jamb should be sealed to prevent further rot

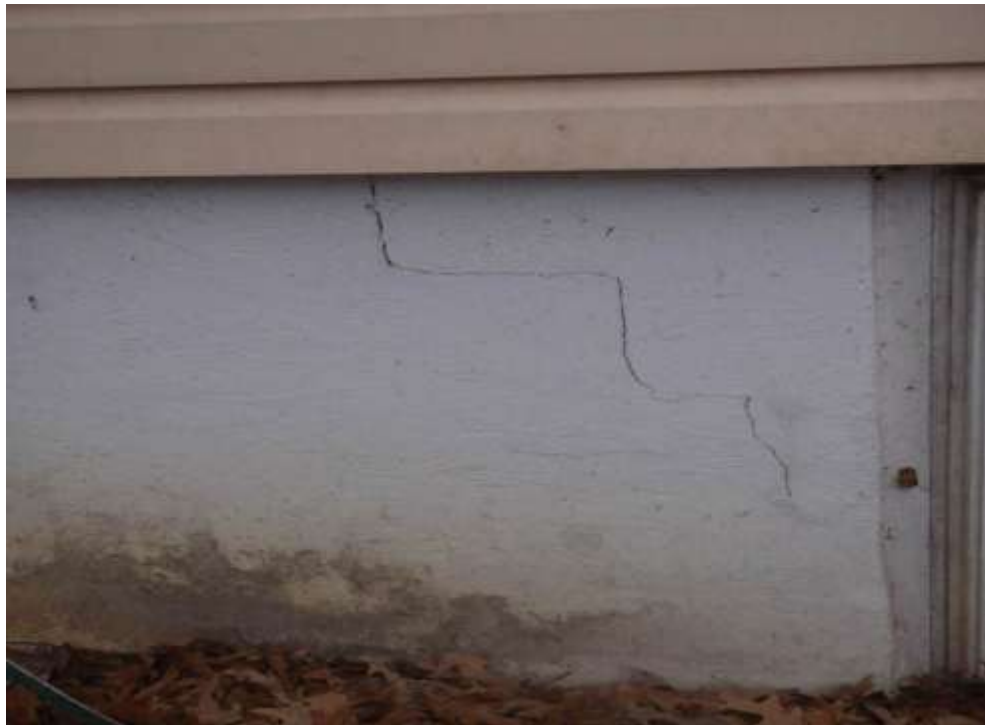
#2 – settlement cracks in basement concrete foundation should be inspected, filled and sealed

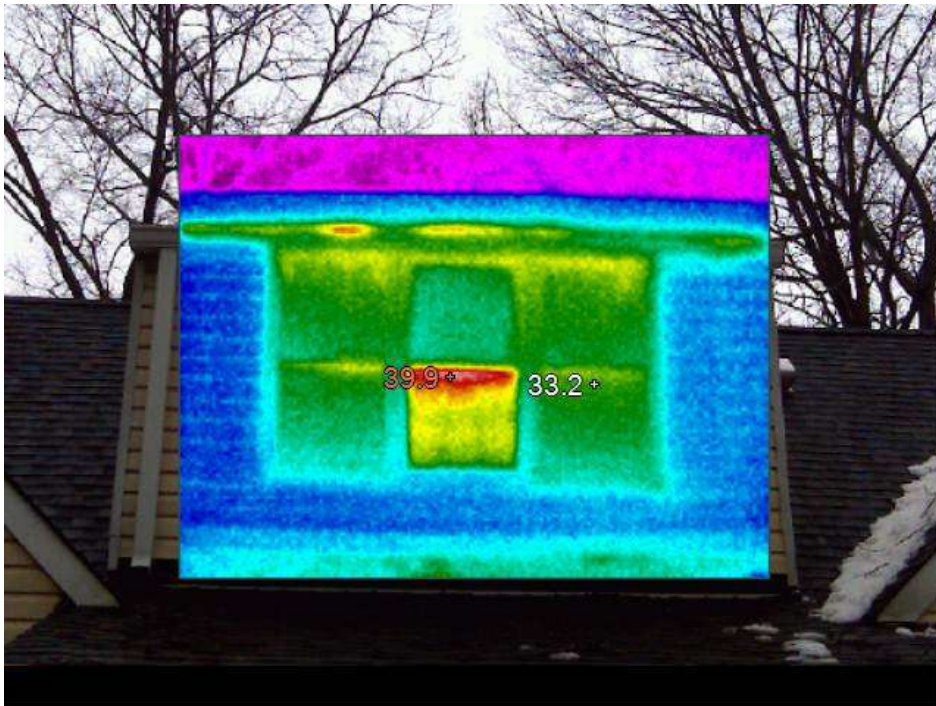
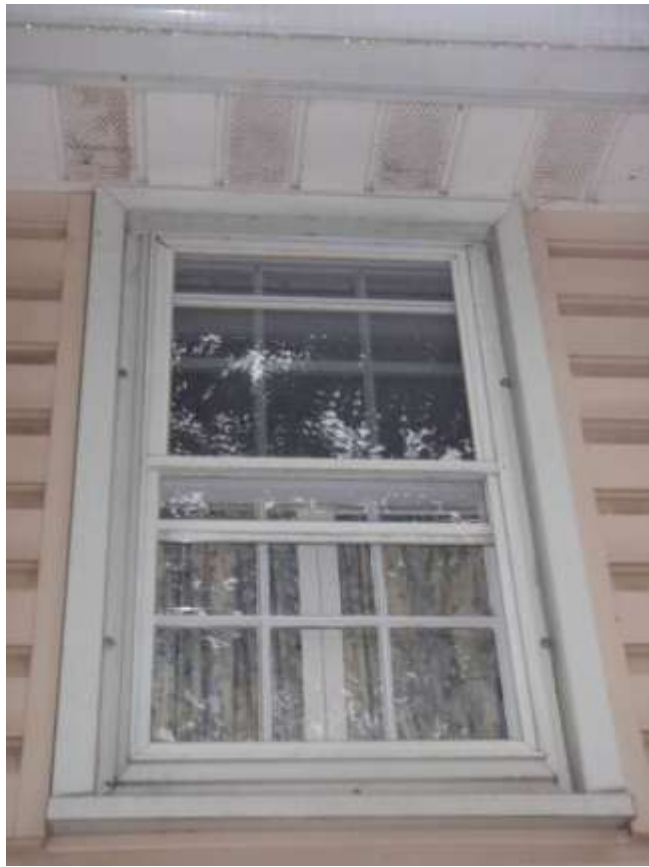
#3 – check to make sure that all storm windows are completely sealed to prevent air infiltration and debris/insect collection between windows.

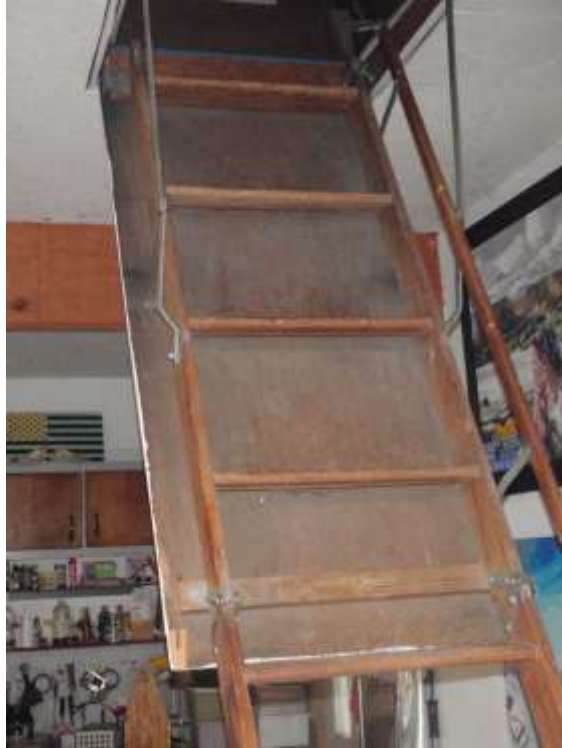
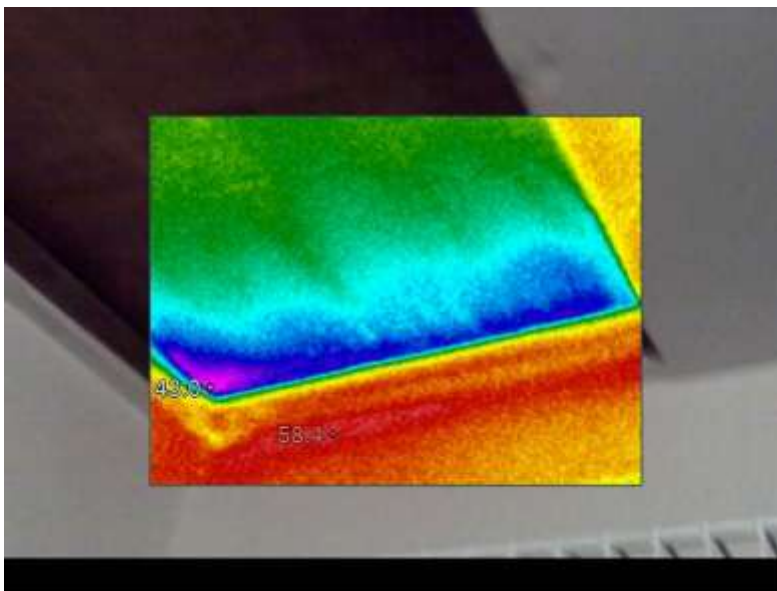
### **Issue #1: Uninsulated (Dropdown) Attic Hatch**

Location/Description: *Substantial leakage through attic hatches in master closet and studio.*

*Below: purple areas show cold air entering closet through gaps in attic hatch.*

Recommendation: *Insulate using custom-fit rigid board and fiberglass and gaskets as*

part of overall attic insulation job. Also consider installing an Attic Tent™ for the best quality long-term solution (a zip-up insulated canvas cover).

Priority: Moderate.

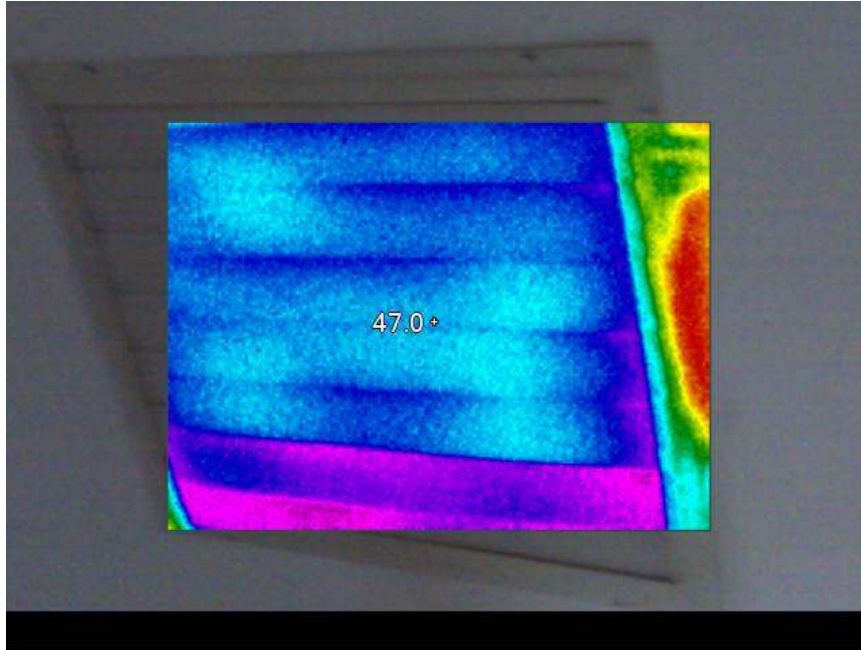
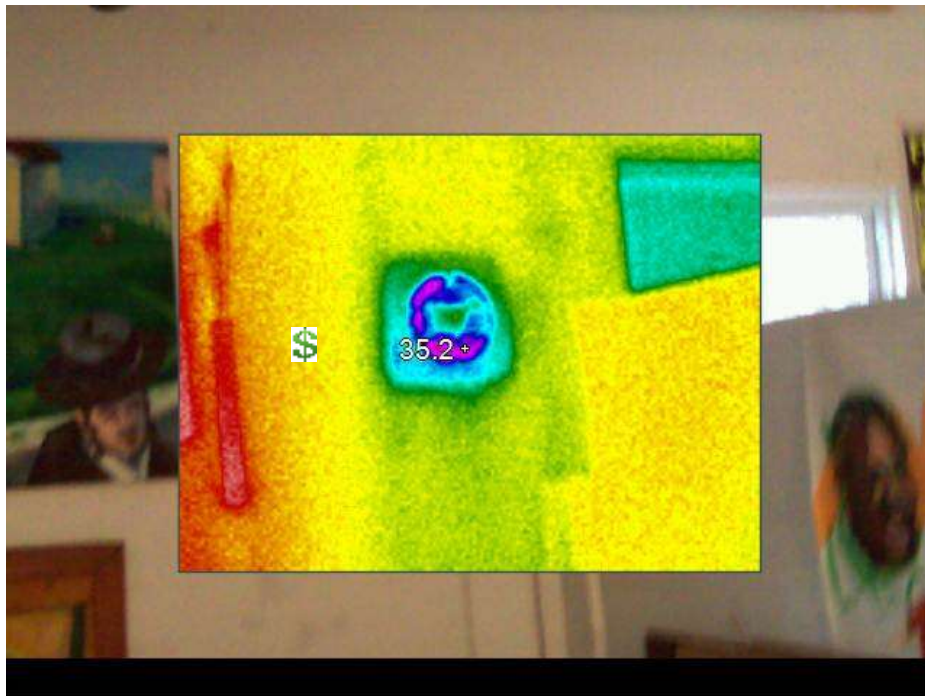
## Issue #2: Summer Vents

Location/Description: All fan openings should be covered in winter with reusable seals to prevent cold air infiltration into living spaces.

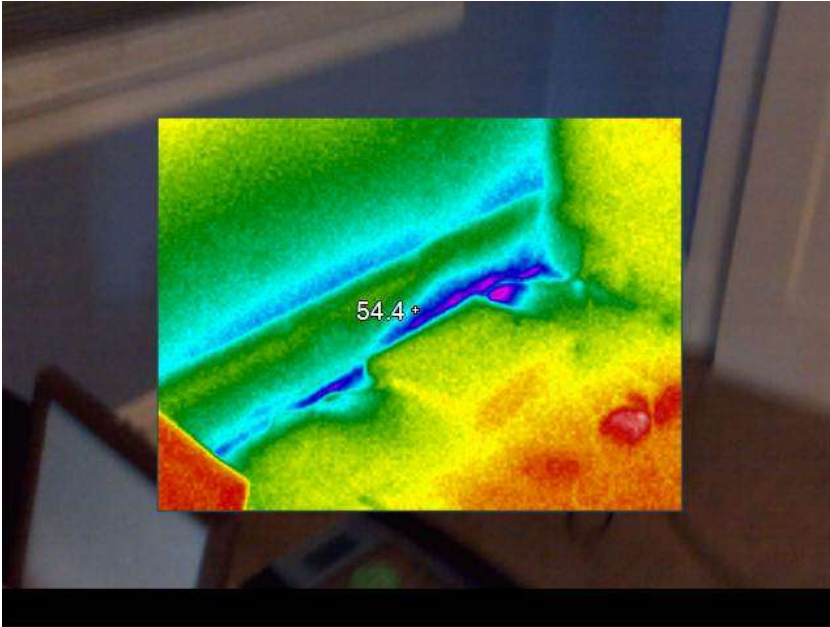
### **Issue #2: Floor Trim/Molding throughout House**

*Cold air infiltrating perimeter of home through slight gap in floor trim/molding (infrared picture below is from another structure but is meant to be indicative of what we would expect to find in your home).*

Recommendation: Caulk all baseboard trim and molding runs throughout perimeter of each level.

Priority: Moderate.

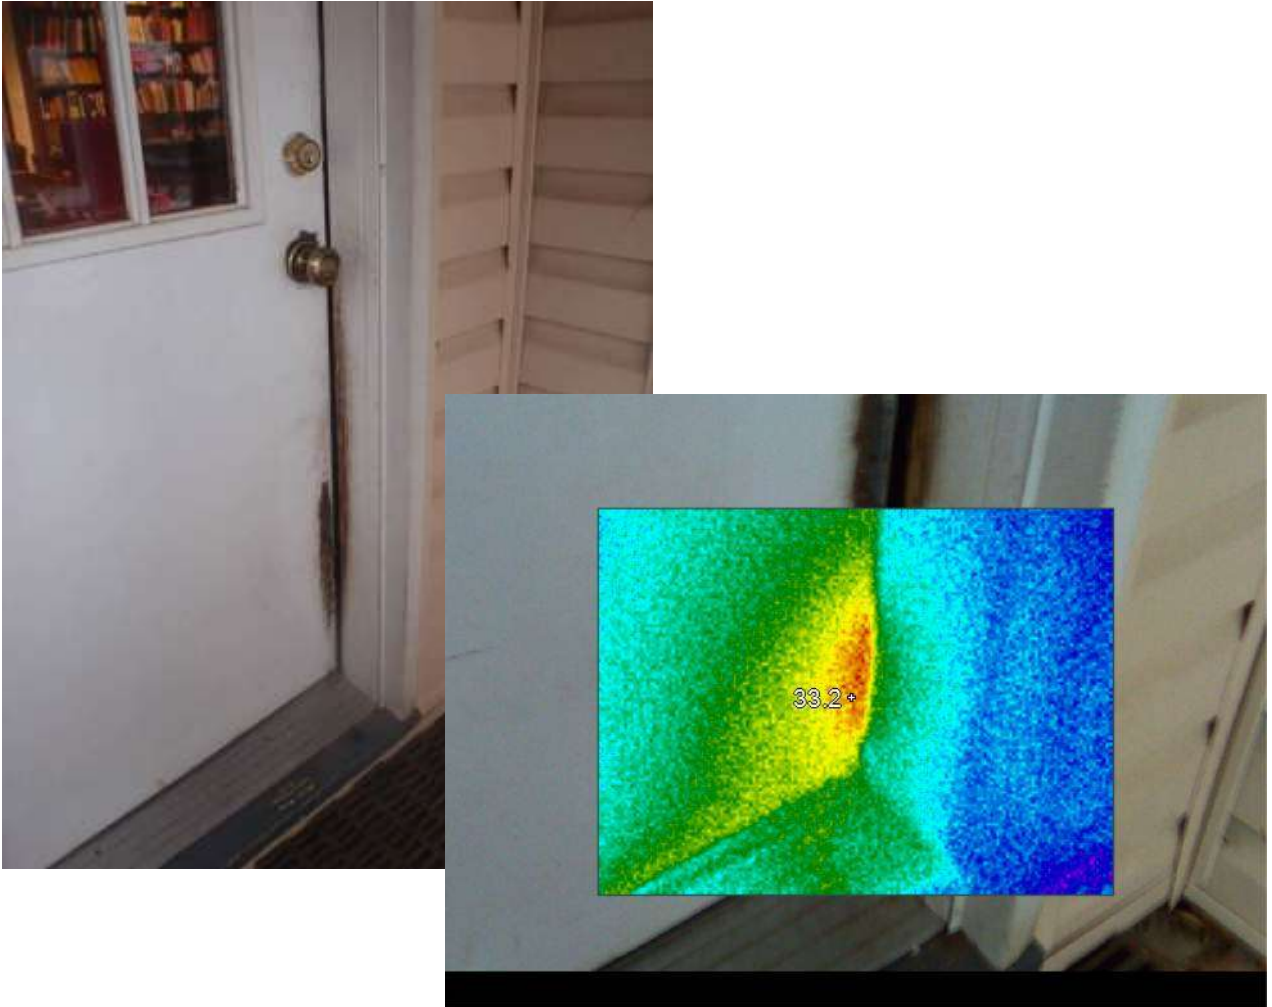
*Below: a visible air gap at door is letting out conditioned air*

Recommendation: Weatherstrip doors with high-quality foam weatherstripping and a 3-fold sweep at door thresholds for a tighter seal.

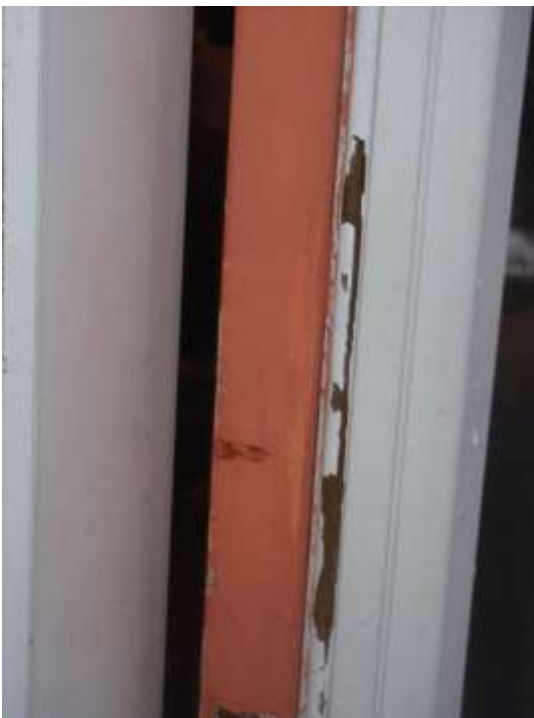
Above: Gaps in barn door (attic) should be filled with weatherstripping as part of work in attic to achieve more comfortable studio.

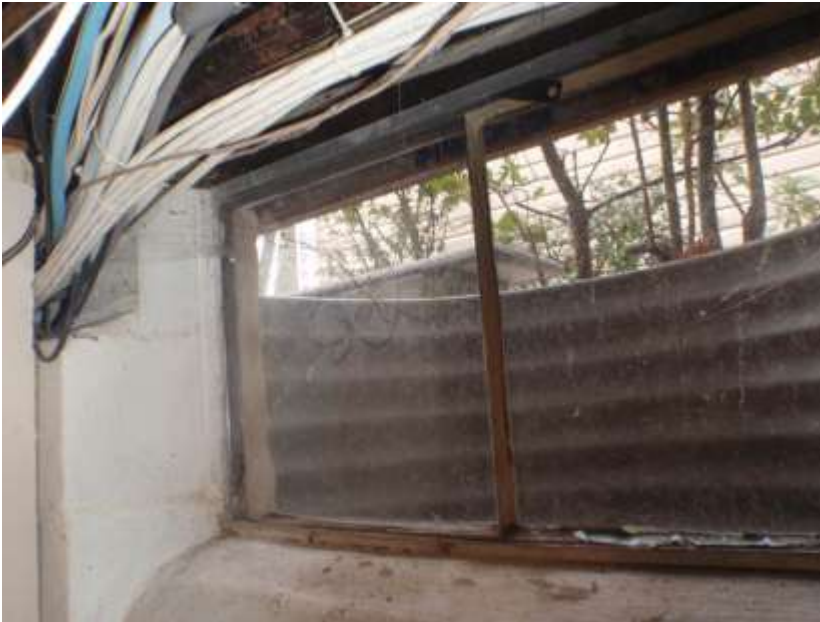
*Above: The basement windows seem to be the leakiest in the entire house and should be given first priority for caulking. The visible air gaps can allow insects (i.e. - stinkbugs) into house.*

*Recommendation:* *Thorough indoor and outdoor caulking to achieve tighter seal.*

*Priority:* *Moderate.*

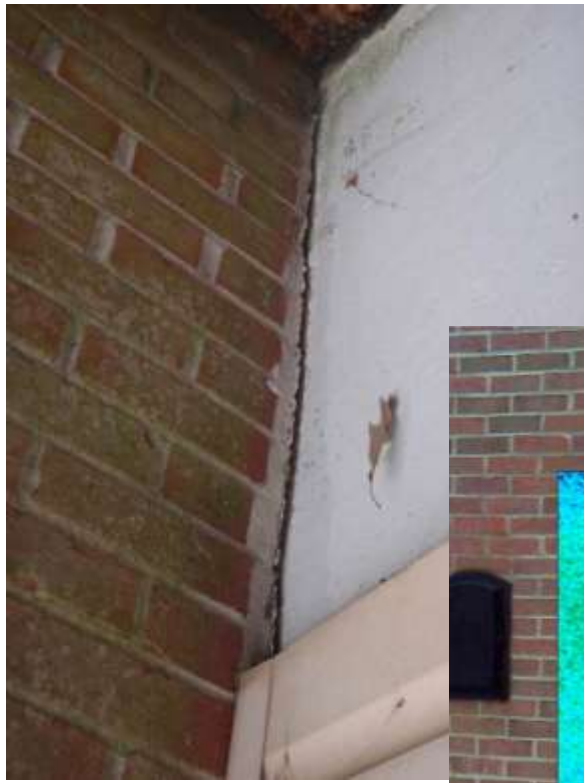
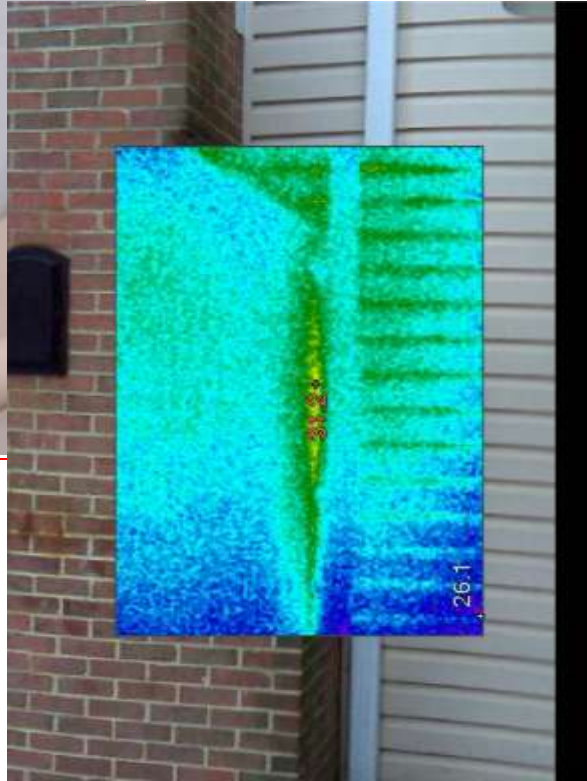
*Above: gap at chimney connection should also be sealed as part of exterior caulking job.*

*Your fireplaces themselves were not especially leaky, but to properly seal it when not in use, insert a removable “Chimney Balloon” to seal the flue and stop draft in and out of chimney. The chimney-siding connections should be thoroughly caulked as part of exterior sealing job.*

Priority: Moderate.

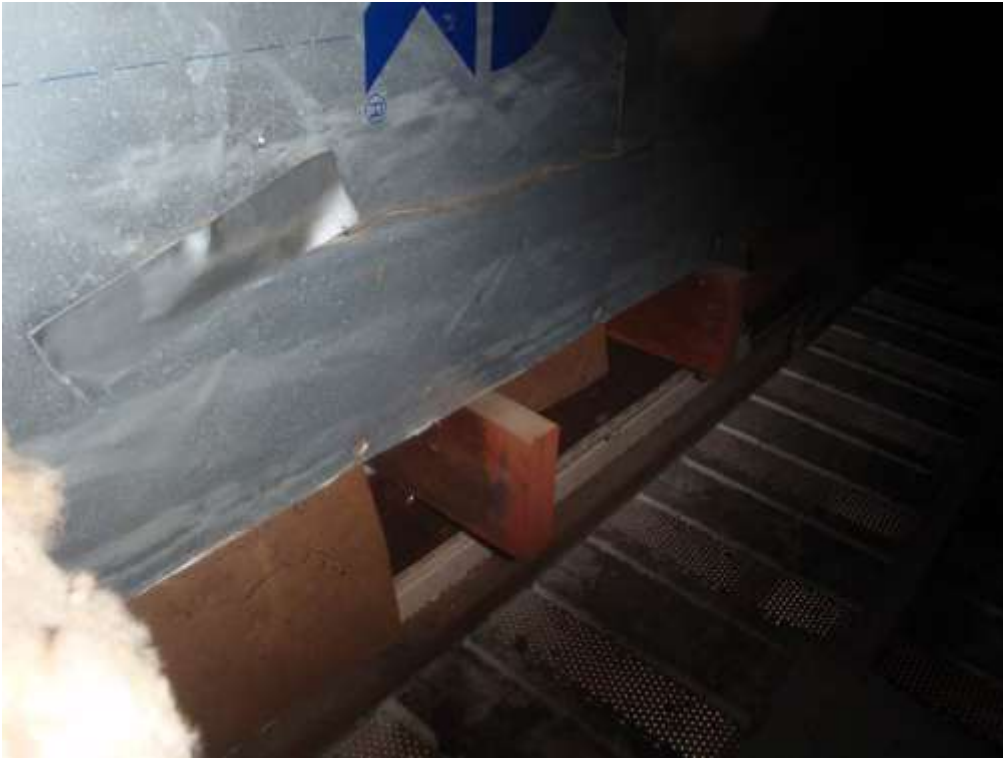
**Issue #1: Air Infiltration into home through leaks behind front porch soffit**

Description: Air is entering the home from open gaps behind the porch soffit, which is infiltrating the ceiling above kitchen and downstairs bathroom.

*Recommendation: Remove soffits, seal air-gaps using rigid foam board and spray foam, stuff fiberglass batts into open areas, and reattach soffits. Work should also include insulating accessible pipe runs in bathroom (pipe that had frozen).*

*Priority: Very High.*

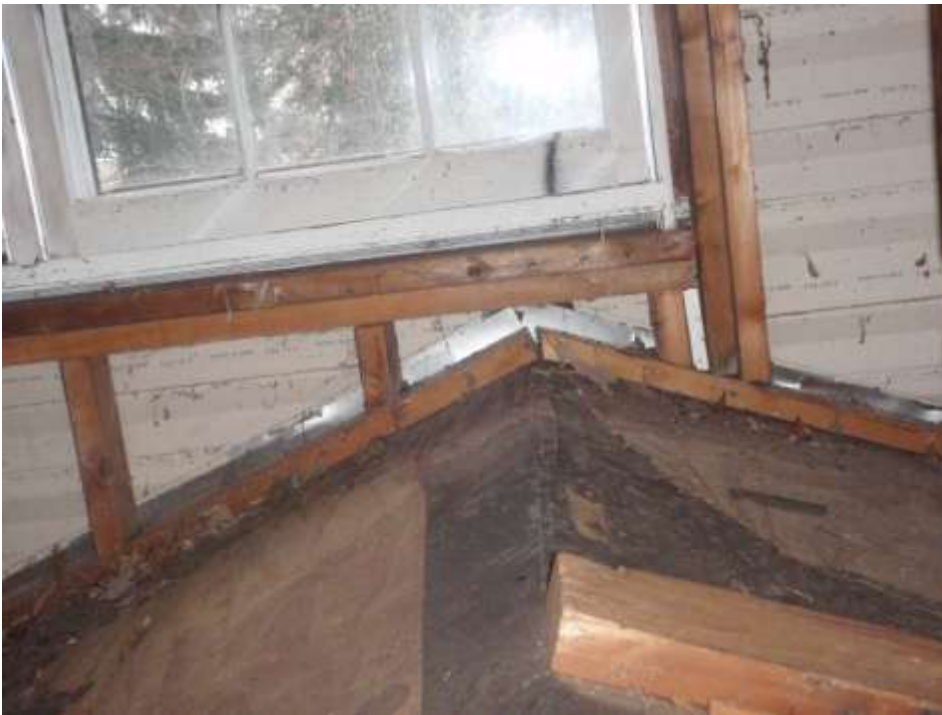
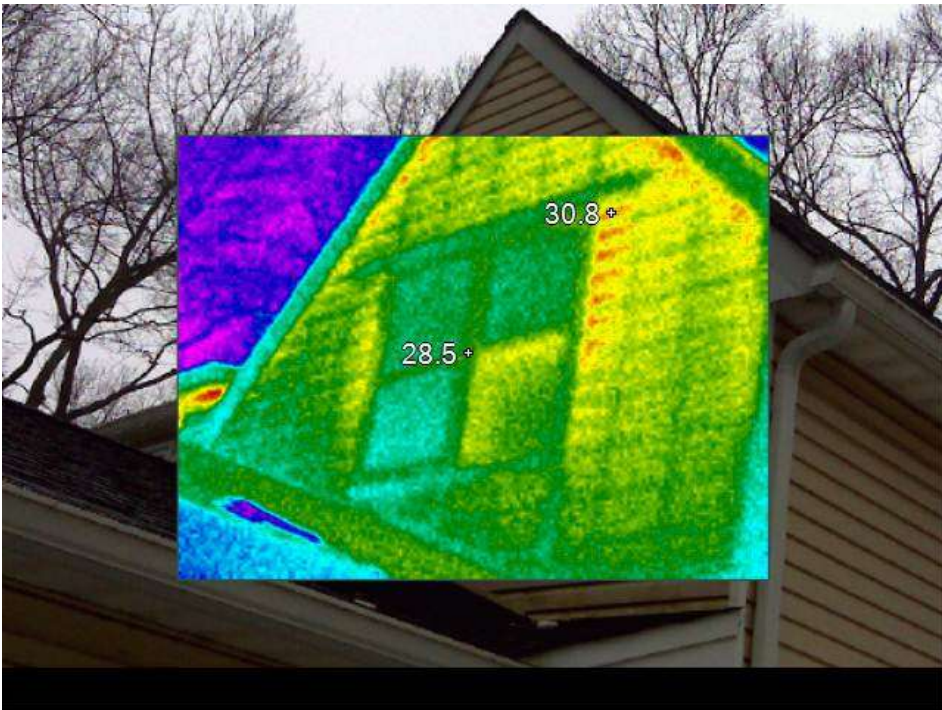
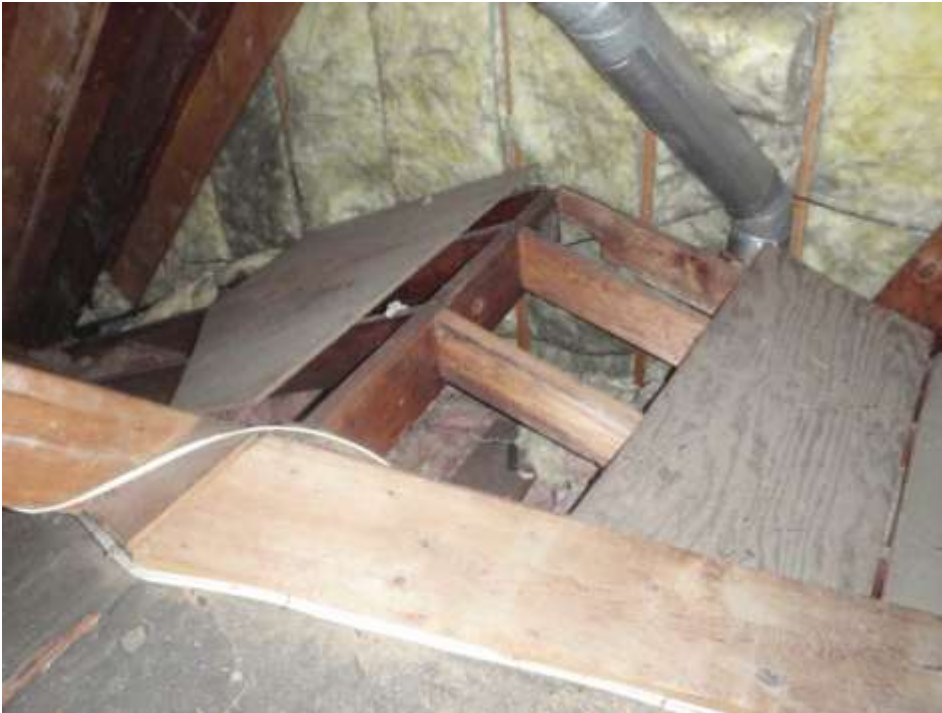
**Issue #2: Air Infiltration into living spaces through poorly sealed and insulated side wall over living room (with wood stove)**

*Description: An entire upper wall above the living room-sunroom connection (covered with interior siding) was never properly sealed and insulated and is extremely leaky. There is also substantial leakage into main living spaces through gaps in the floor.*

Leakage from the uninsulated wall in the living room attic, adjacent to sunroom (above), is visible below as heat escaping (red).

Recommendation: thoroughly seal gaps and cracks in floor using spray foam and properly insulate side wall to min R-19, using fiberglass batts (and spray foam at any gaps and cracks)

Priority: Very High.

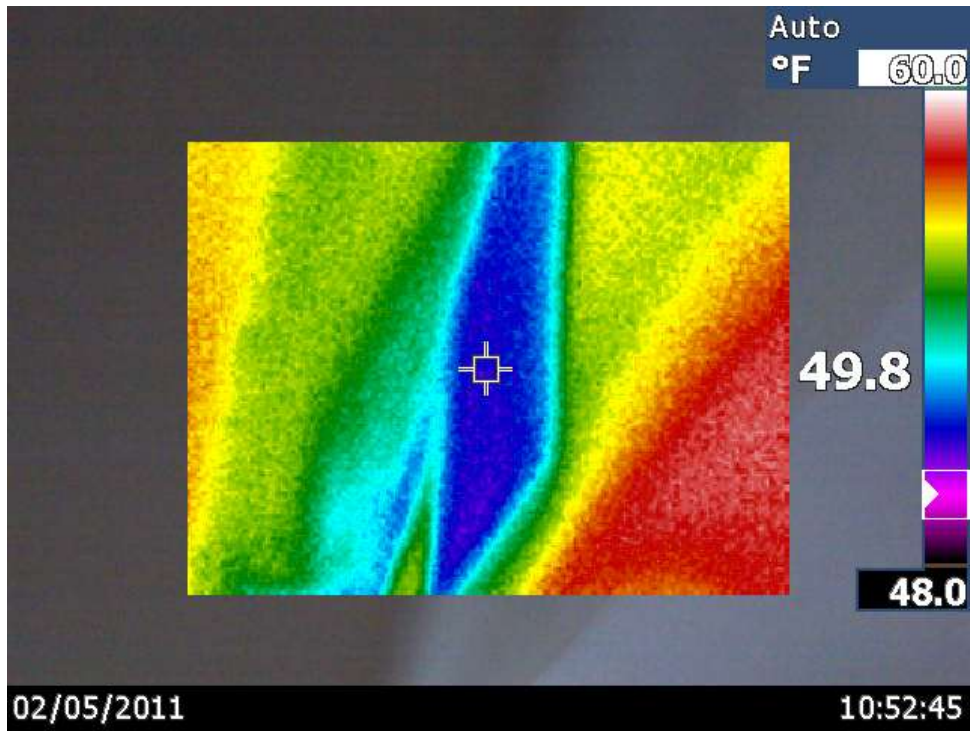
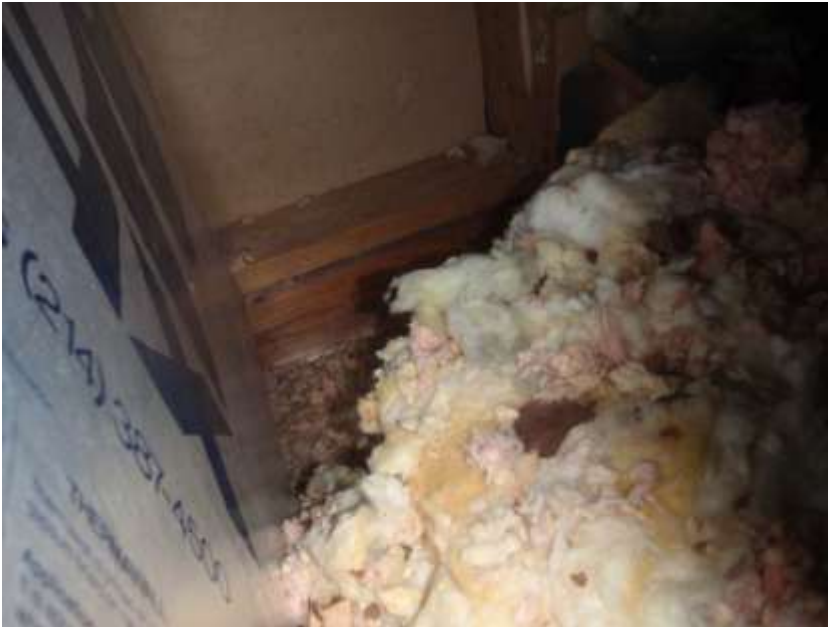
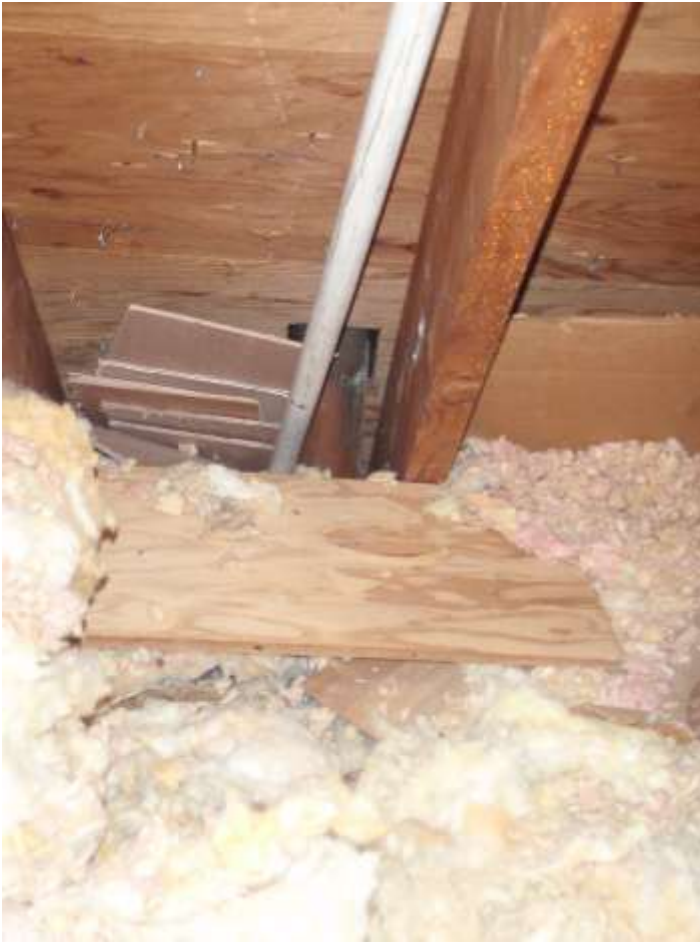
**Issue #3: Air Infiltration into home and stairwell through leaks and missing insulation panel in bedroom closet**

Description: A missing insulation panel in the side attic (adjacent to master bedroom; access through bedroom closet) and air gaps in the attic floor are the source of leakage down through the stairwell.

Above: missing panel visible as blue (colder) air leakage in IR picture above.

*Recommendation: Insulate missing panel using custom-fit rigid board and gaskets; thoroughly seal any air gaps (including the visible gap around plumbing chase in picture above).*

*Priority: High.*

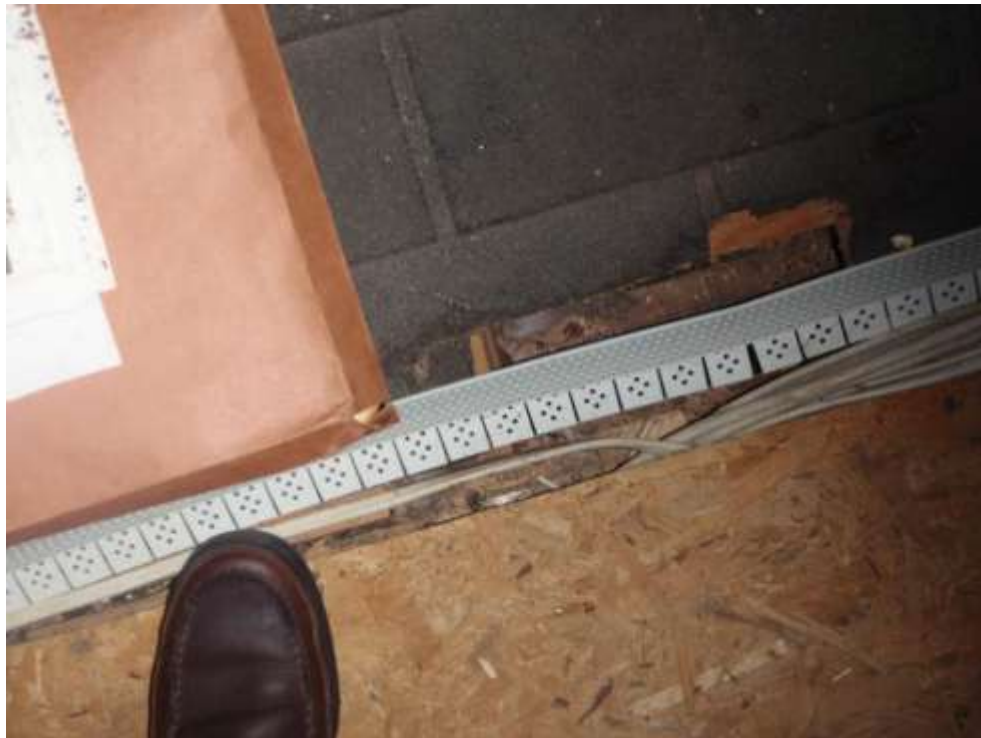
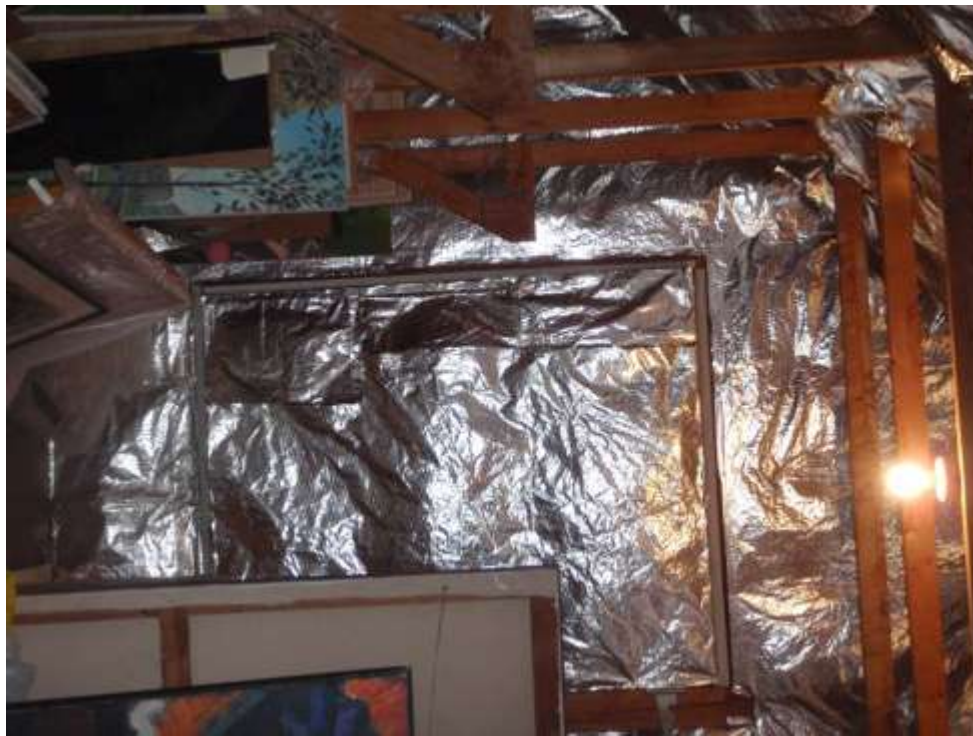
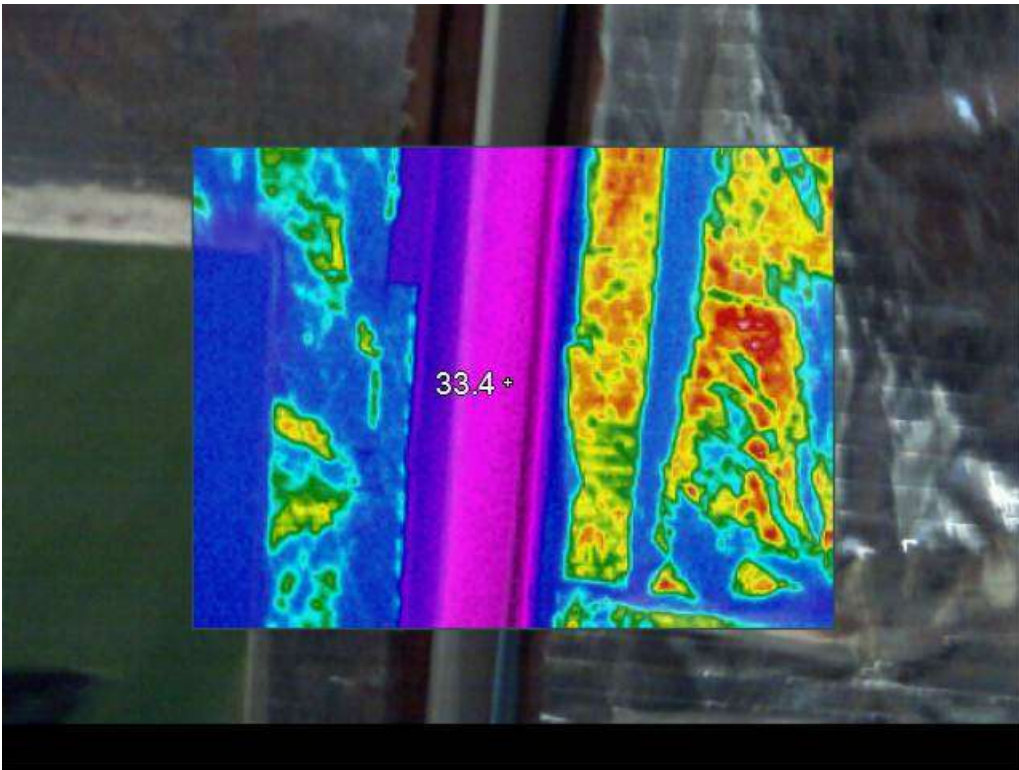
#### **Issue #4: Air Infiltration into studio through leaks in attic ceiling above studio**

*Description: Excessive leakage into studio through 3 main gaps: i.) deficient weatherstripping at barn door; ii.) no insulation of drop-down attic hatch; and iii.) air leakage at the studio-living room attic connection.*

*Above and below: cold air entering the perimeter of the attic door above studio; door should be weatherstripped to achieve more constant attic temperatures.*

*Recommendation: Air seal all 3 areas using weatherstripping and spray foam.*

Recommendation: Insulate using custom-fit rigid board and gaskets.

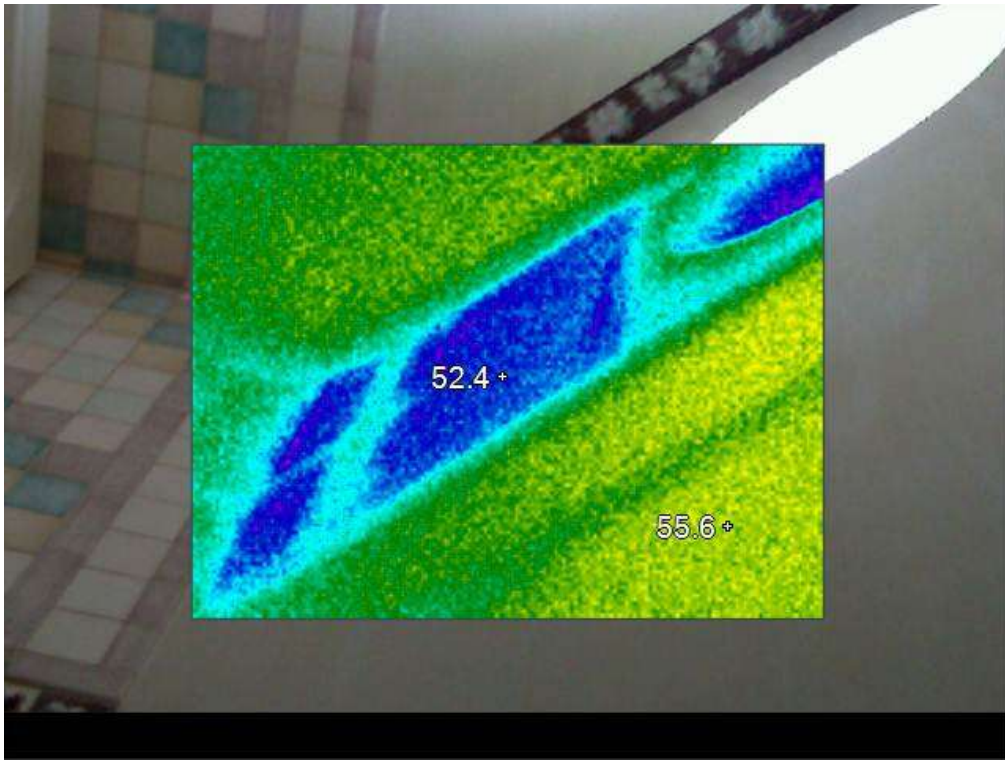
**Issue #5: Air Infiltration into bathroom through leak in missing insulation panel over bathtub**

Description: One other area – under the window above the master bathtub -- was also discovered to be missing insulation.

Recommendation: Inject spray foam to fill crevice left by missing insulation panel.

Priority: Low.

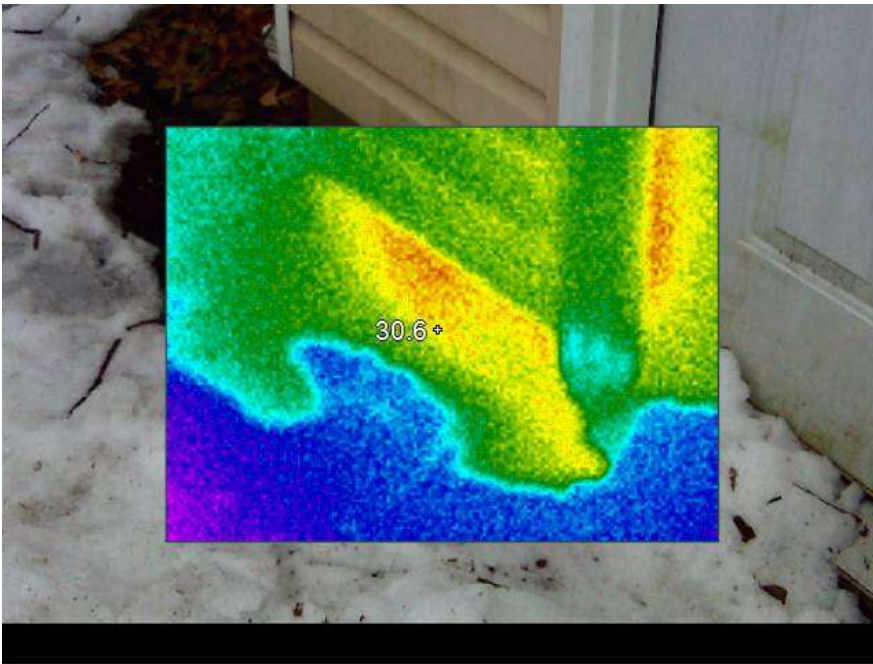
Because your basement rim joist is not airsealed, a large amount of unconditioned outside air can easily pass through the wooden beam into the house.

*Above: heat loss from the basement foundation is visible to the IR camera from outside the building.*

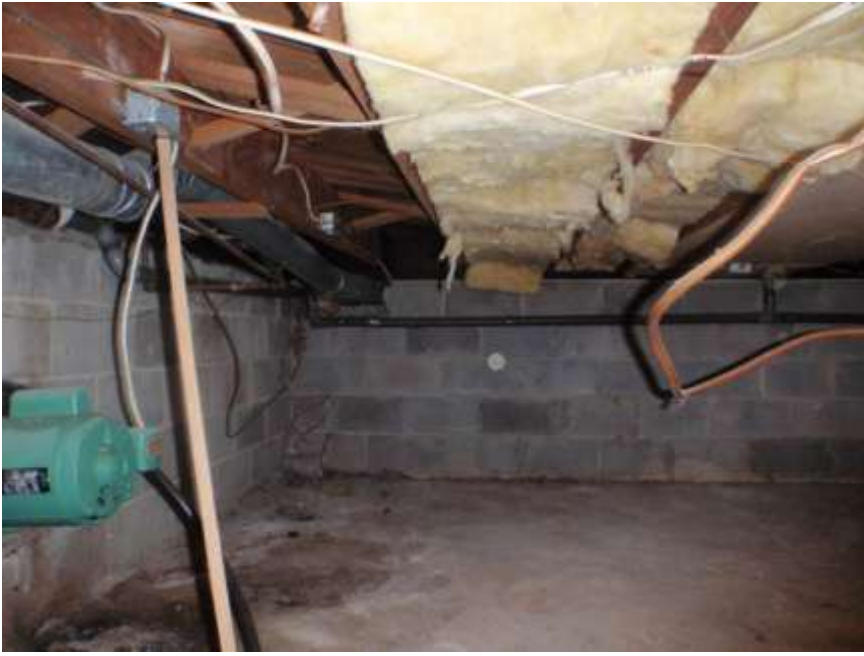
*Above: though the crawlspace is well-insulated, it is important to thoroughly air-seal the perimeter of this space*

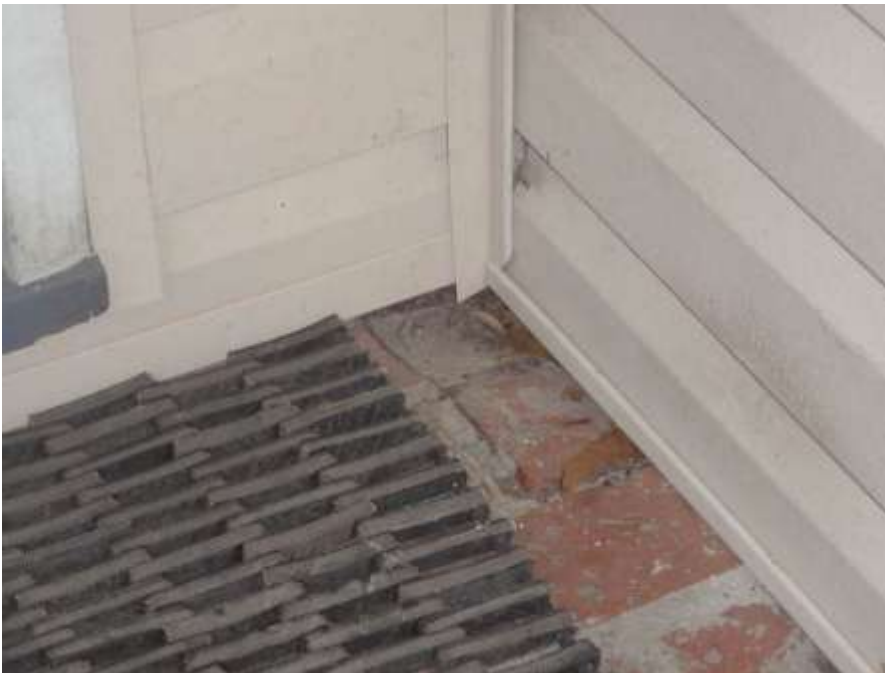
*Above: as part of exterior caulking job, this crack in brick, which lets out conditioned air from basement, should be sealed*

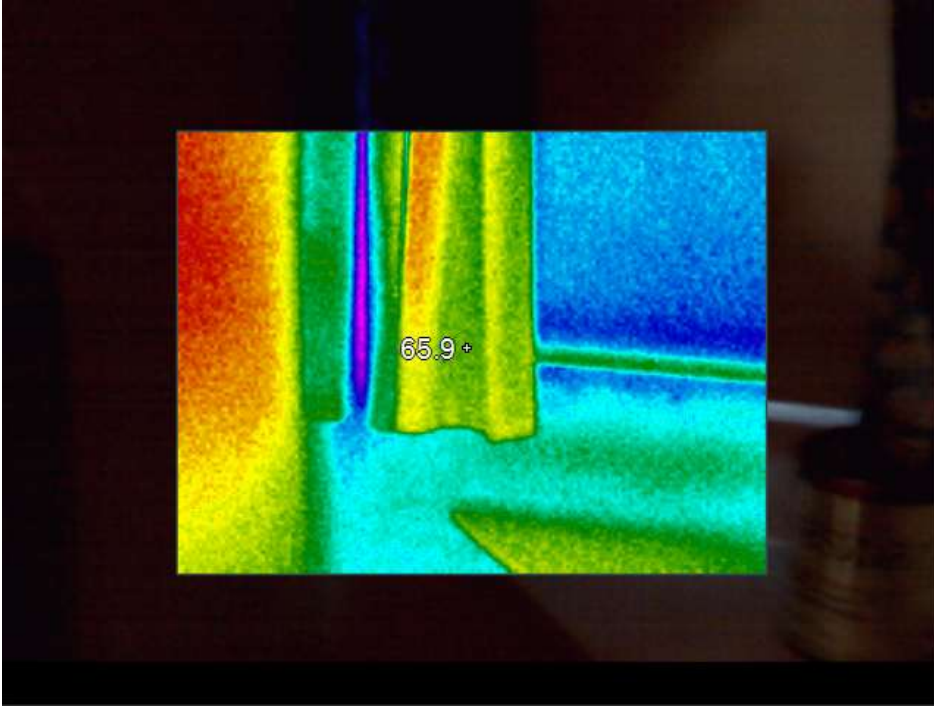
**Savings Opportunity #2:** You can continue to install thermally efficient blinds at all windows for improved insulation (below you can see a 10 ° surface temperature difference in the curtain and window glass).
