## **“Building Envelope Energy Efficiency Analysis”**

**Doe Residence**  
123 Energy Efficient Lane  
Severna Park, MD 21146

February 17, 2011  
Survey #: Z-1108-Doe

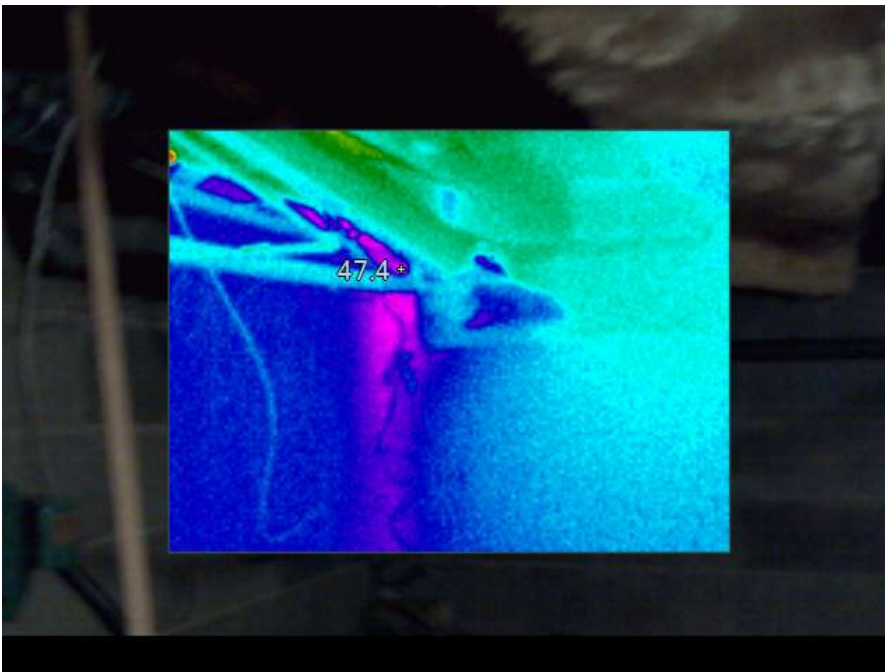
Because your basement rim joist is not airsealed, a large amount of unconditioned outside air can easily pass through the wooden beam into the house.

*Below: This pattern of cold air infiltration into basement rim joist gaps is typical of most homes constructed without an insulated rim joist or basement walls. (IR images are from other structures and are only representative).*

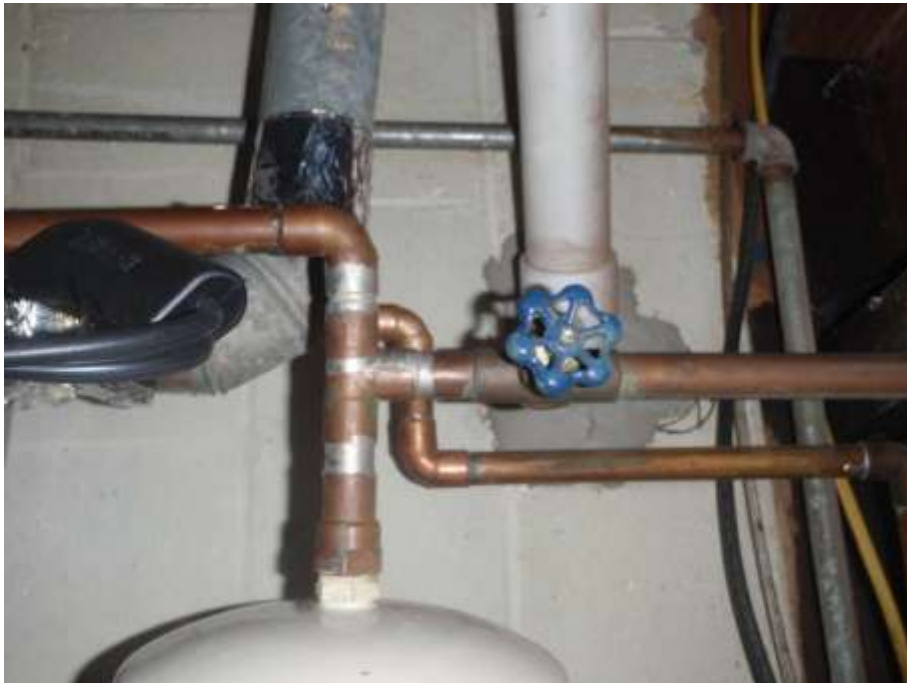
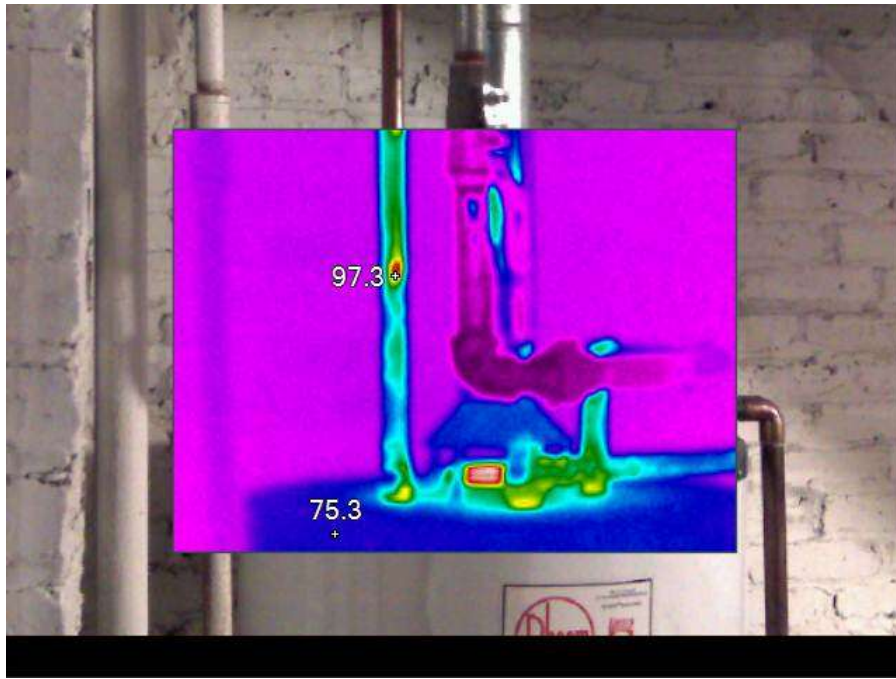
**Savings Opportunity #1:** Wrapping your gas hot water heater and wrapping all accessible pipes with insulating wrap (min. R-4) will minimize standby loss and heat your water more efficiently (IR picture below is from another system and is merely representative).

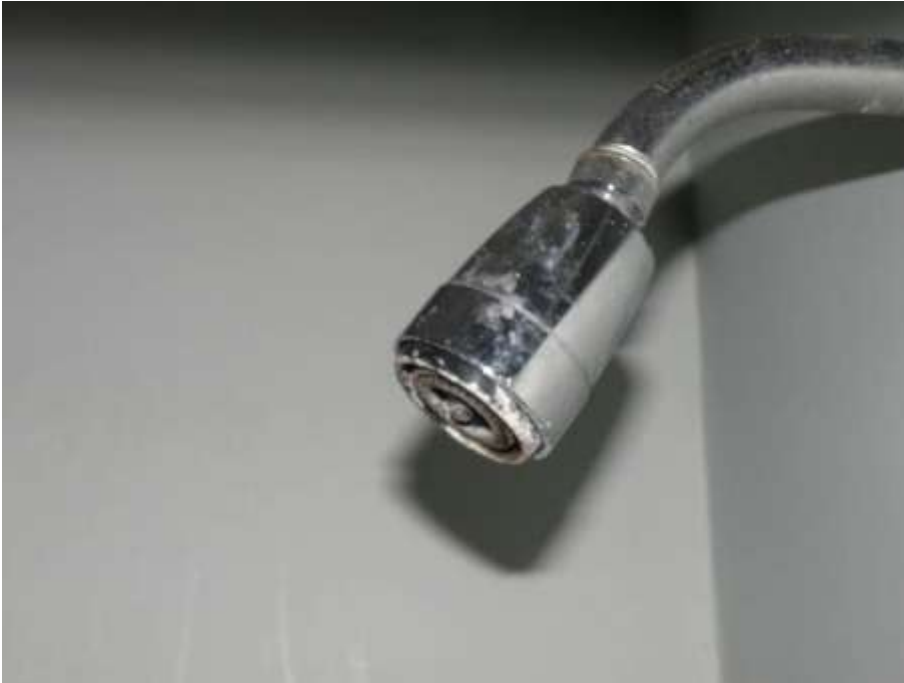
**Savings Opportunity #2:** Continuing to upgrade to low-flow shower fixtures and faucet aerators can reduce your water consumption and baseload hot water requirements ((IR picture below is from another system and is merely representative).

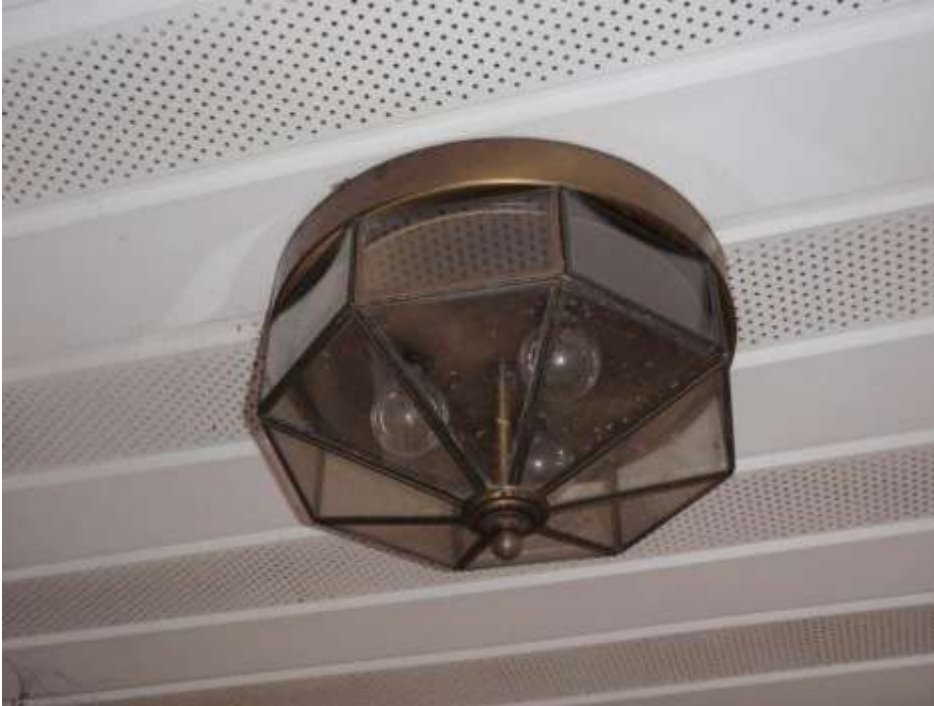
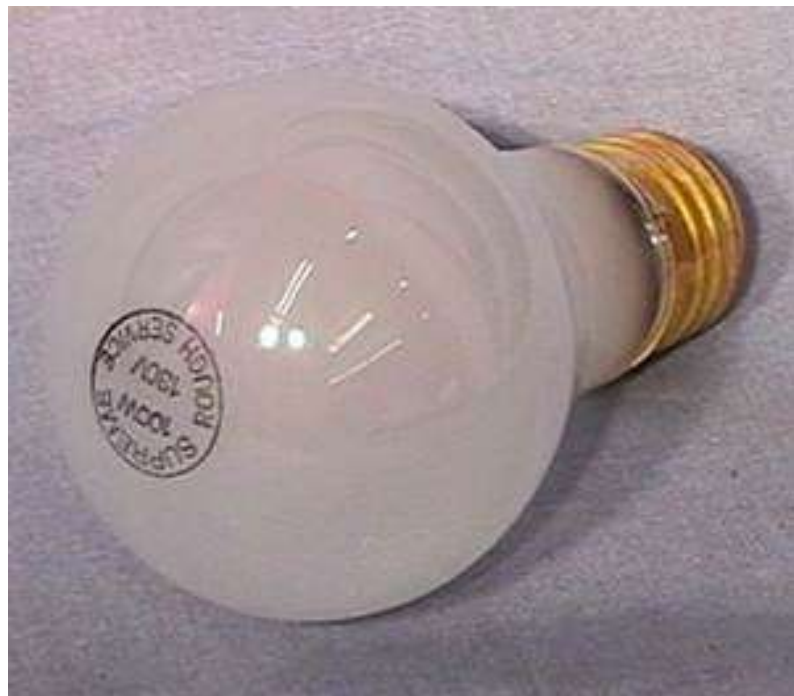
**Savings Opportunity #1:** You can continue to convert your incandescent bulbs to CFLs (now available in a great variety of shapes and sizes, including dimmable) and even LEDs for improved baseload savings.

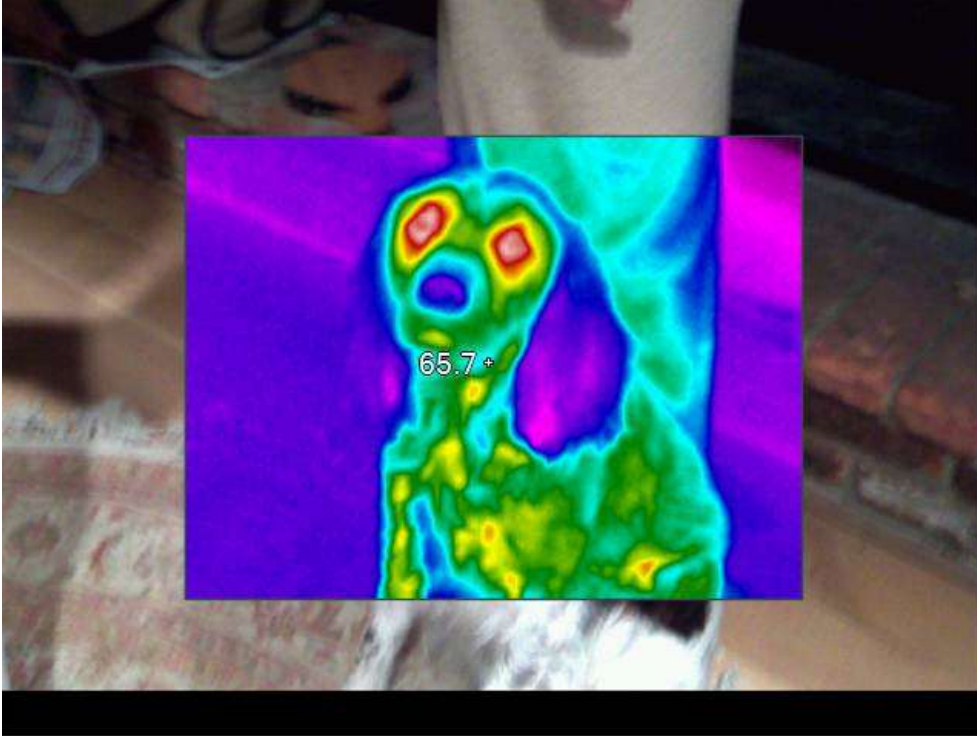
The following thermal anomalies were also detected in the course of the inspection.
